From Obsolescence to Adaptive Re-use

Rehabilitating Building 661 at Langley Air Force Base

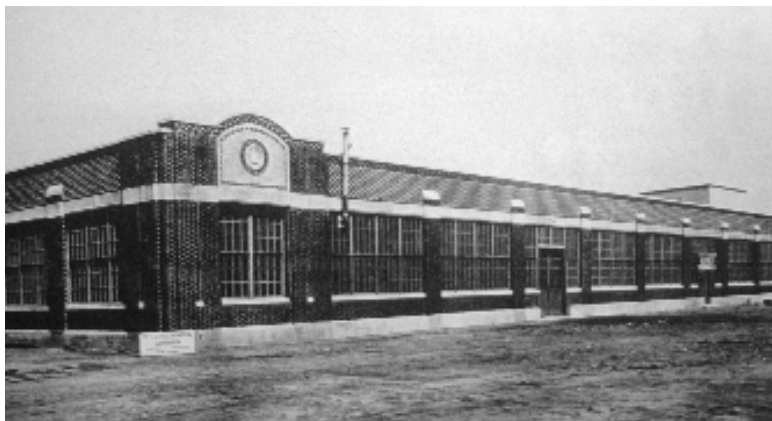
*Machine Shop
(c. 1918),
Langley Field,
Virginia.*

Building 661, one of the first permanent structures on the base, was designed as a machine shop with two rows of concrete-framed sawtooth skylights to illuminate the interior portions of the building. The exterior was built of load-bearing brick piers infilled with brick under concrete window sills and steel-framed windows. A continuous band of reinforced concrete at the lintel height supports concrete beams. A grid of interior columns spaced 20 feet on center also supports the beams, which in turn support the reinforced concrete roof slab and the skylight structures.

This two-component structural system, brick on the exterior and concrete on the interior, reflects a refinement of 19th-century industrial construction methods where load-bearing masonry walls enclosed interiors with heavy timber frames, and later, cast iron frames. Many of Kahn's industrial structures were of all-concrete construction including exposed concrete supports instead of brick piers, and glazing running the full width from column to column. But such a construction method was perhaps considered too raw and unfinished for the Machine Shop at

Langley Field, which was intended to be a fairly prominent building. Attention was lavished on the decorative brickwork that adorns the exterior of the parapet and the re-entrant corner piers.

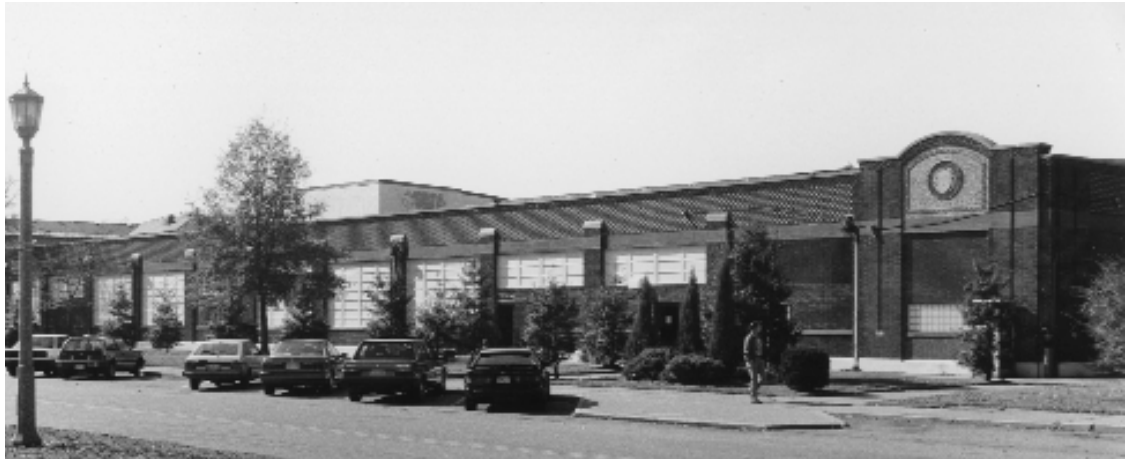
Building 661,
former Machine
Shop (c. 1995,
before rehabili-
tation).

Building 661 was constructed as a machine shop, used for a time as a garage, converted to a Post Exchange and commissary, then used as a publications warehouse, mail distribution center, and cafeteria. At some point in the 1940s, a large addition was constructed along the entire length of the building's rear elevation. A subsequent undated drawing, likely dating to the 1950s, indicates the skylights were sealed with asbestos board and covered with roofing material. Insult was added to injury in the 1960s when a number of steel-framed windows were replaced with eight-inch glass block.

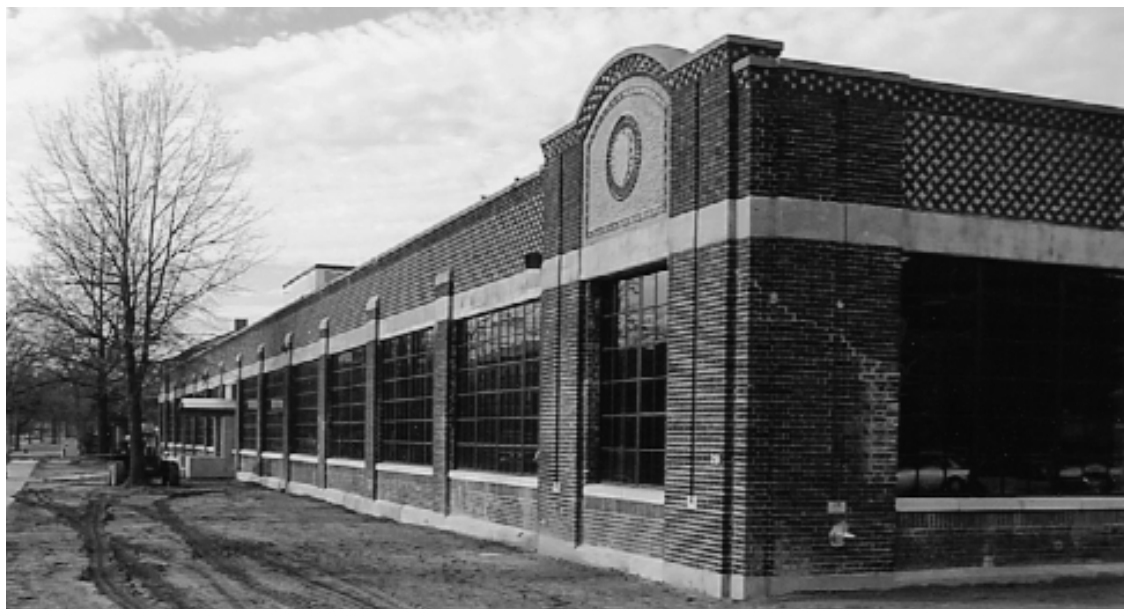
Building 661,
former Machine
Shop with reha-
bilitation nearing
completion,
December 1999.
